DOE/NASA/0008-12
NASA CR-165139

CERAMIC REGENERATOR SYSTEMS
DEVELOPMENT PROGRAM — FINAL REPORT

C. A. Fucinari, C. J. Rahnke, V. D. N. Rao, J. K. Vallance
Research Staff
Ford Motor Co.

Prepared for
National Aeronautics and Space Administration
Lewis Research Center
Cleveland, Ohio 44135
Under Contract DEN 3-8

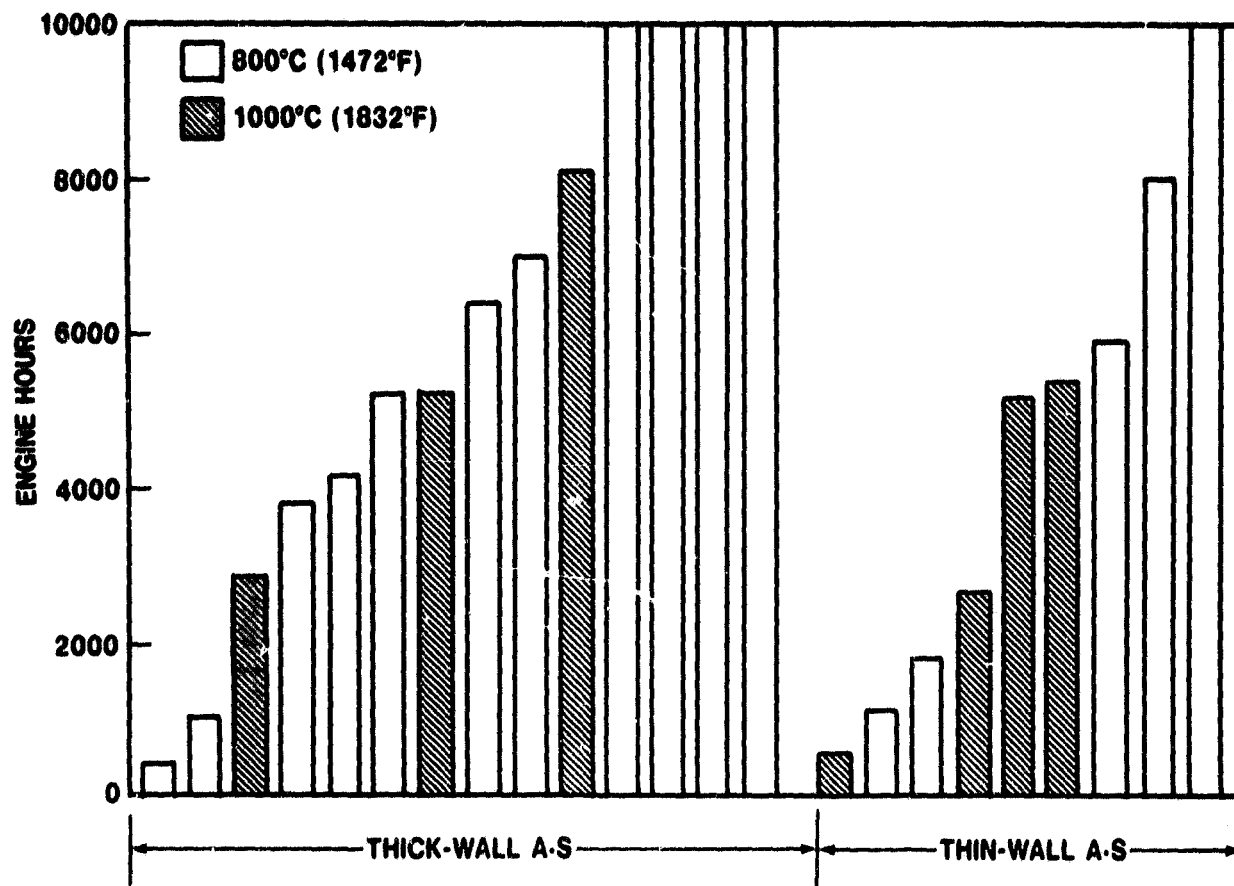
The running history of all Supplier A's AS cores that have been engine tested are shown in Figure I.B.1.3. This figure also includes the seven cores tested at 1000°C (1832°F) and described in Section II.B. Over 125,000 hours of engine test have been accumulated on this material. None of these cores show any serious signs of thermal distress or chemical attack damage. To date, a total of fourteen AS cores have accumulated over 5,000 hours and eight cores have each accumulated over 7,000 hours of engine test without visual distress.

Figure I.B.1.3 Durability Record of All AS Regenerators Engine Tested in the Ford 707 Turbine

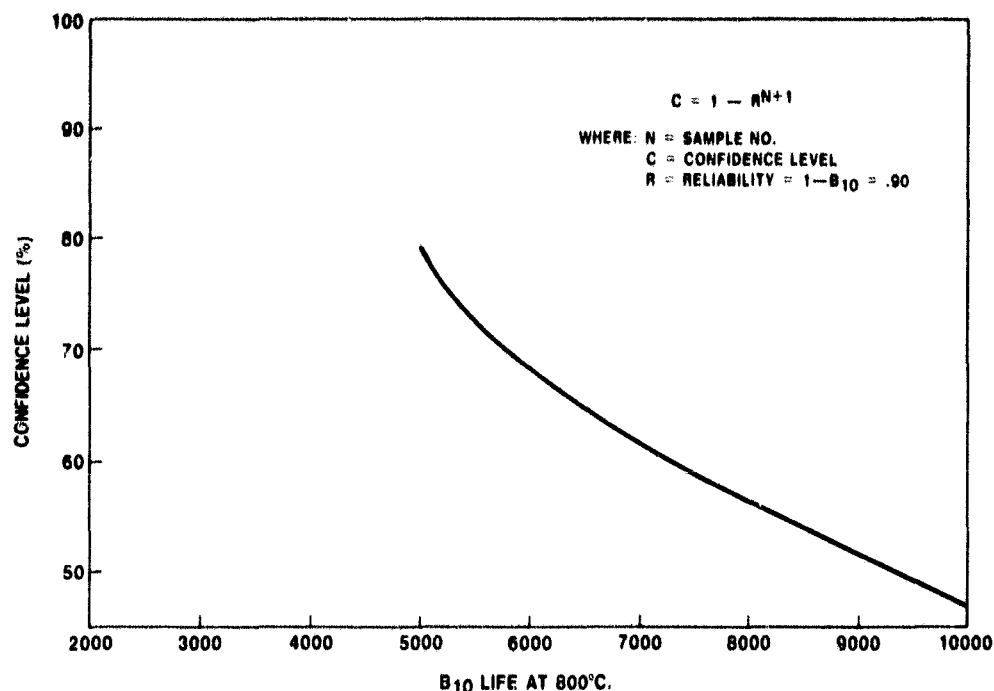
Ford 707 turbine engines. Approximately 38,000 hours of core durability were accumulated on the regenerators used in this sample. The hours at which each of the eleven failures occurred is also tabulated in this figure. The failure data suggests that a B₁₀ life of 600 hours and a B₅₀ life of 1600 hours would probably be representative of the durability of the 1973 LAS ceramic regenerators in most gas turbine applications. The AS test data, on the other hand, shows an 80% confidence in achieving a B₁₀ life of 5000 hours.

Figure I.B.1.4 Reliability Confidence Level for AS Regenerators at 800°C (1472°F)

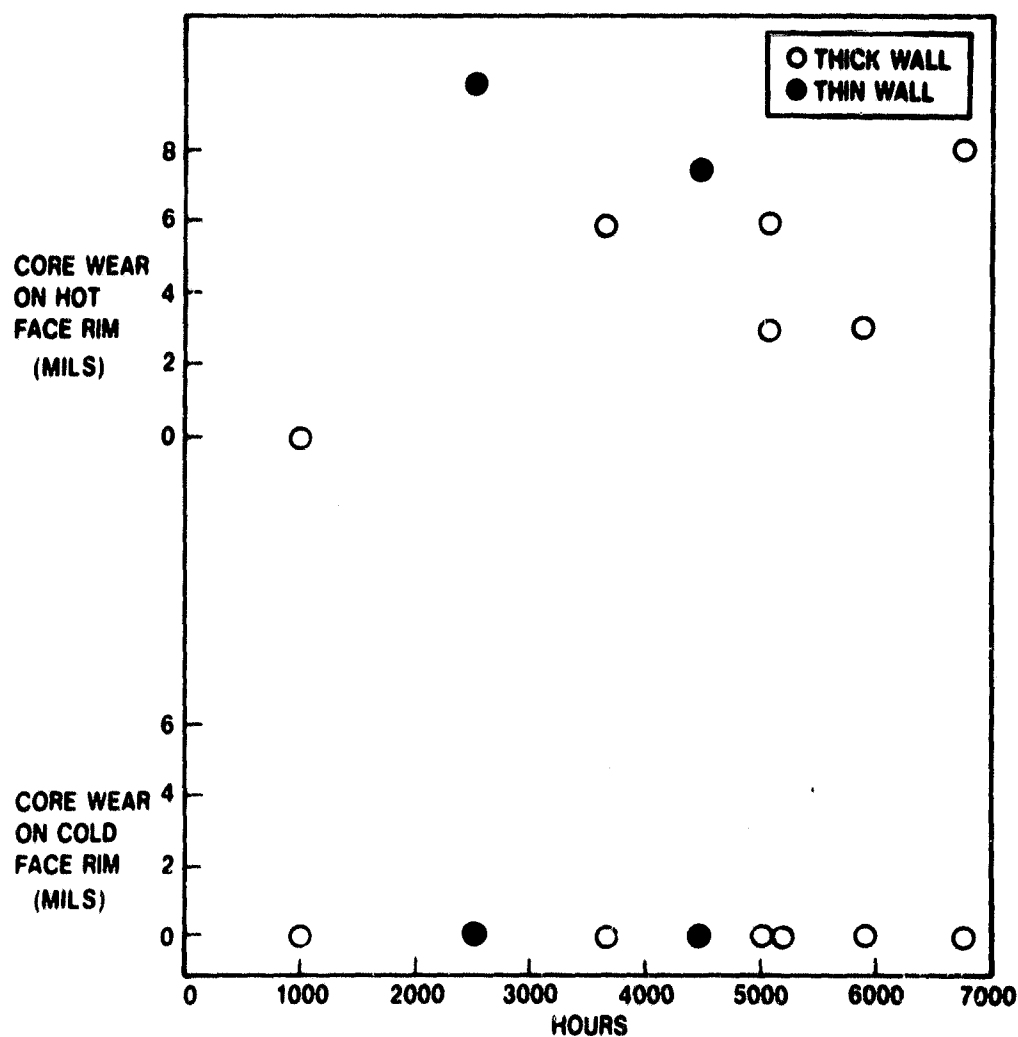
Since the thin-wall AS material has $1/3$ the strength of the old thick-wall LAS material, there was some concern that a regenerator seal system that had been developed for the stronger thick-wall LAS material would damage the surface of the thin-wall AS material. A comparison of the core surface wear under the peripheral seal rubbing shoe for both thick and thin-wall AS cores is shown in figure I.B.2.1. It is believed that, with the Ford seal shoe peripheral coatings, most of the core wear occurs when foreign debris is trapped or passes between the rubbing shoe and the core. Such debris may consist of powdered insulation that has eroded off the main housing insulation blankets, other ceramic dust, or rust. This debris embeds itself in the softer, cold-side rubbing shoe coating, and as a consequence no core wear is observed on this face. The debris cannot embed itself in the harder, hot-side rubbing shoe coating and will cause core surface wear in this location. The large scatter in the hot-side data reflects the random pattern in which wear occurs as well as measurement difficulty. Within the accuracy of these results it appears that the thin-wall core does not exhibit a significantly higher surface wear under the peripheral rubbing seal than does the thick-wall core.

Figure I.B.2.1 Surface Wear of AS Regenerators vs. Operating Hours in an Engine

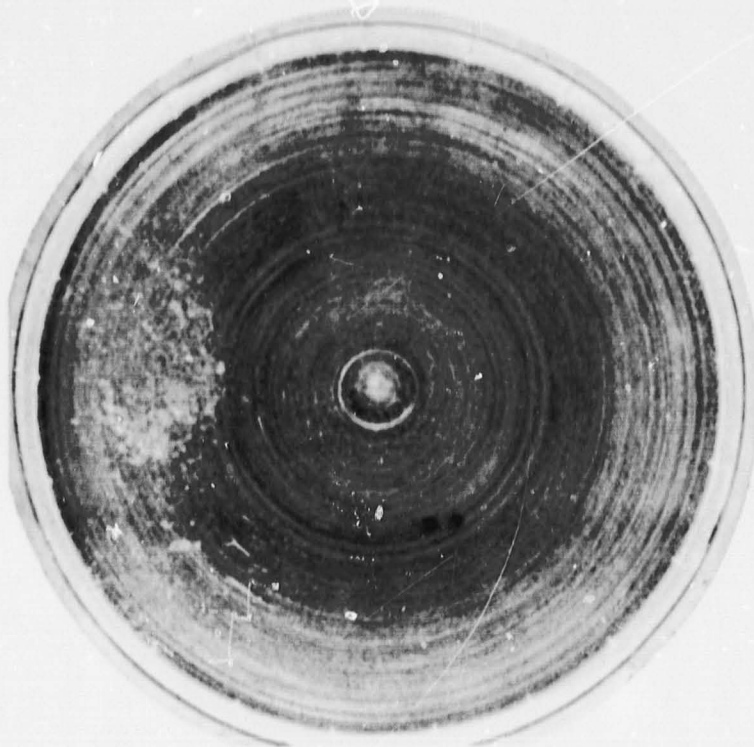
Figure I.B.4.1 AS Core No. 45 Showing Surface Damage
from Power Turbine Failure

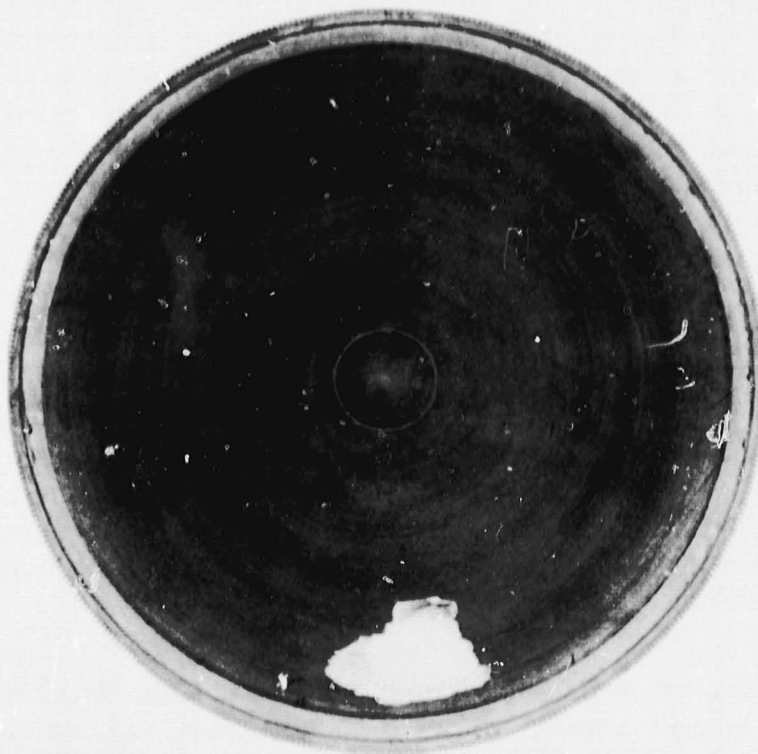
Figure I.B.4.2 AS Core No. 32 Showing Hole Made in Core
by Debris from Power Turbine Failure

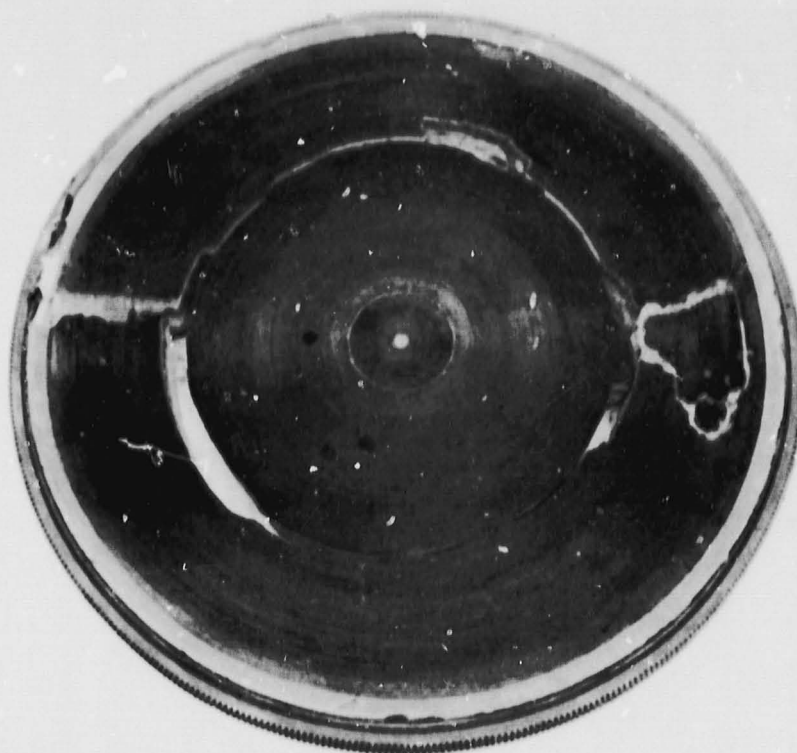
Figure I.B.4.3 AS Core No. 32 Showing Final Failure of Core Initiated in Region Damaged by Power Turbine Failure

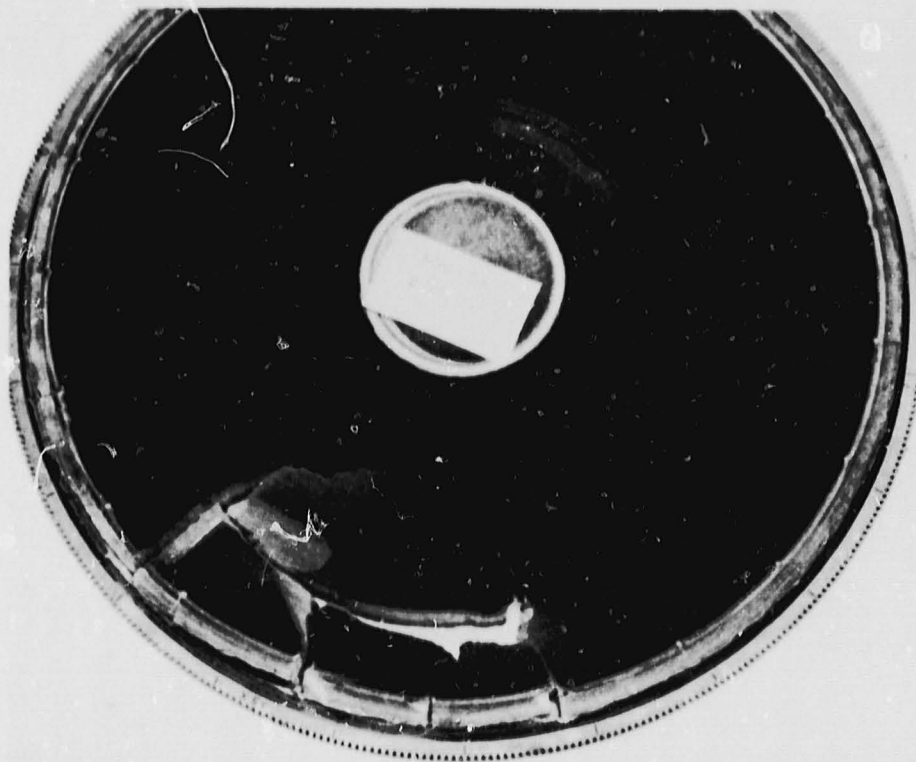
Figure I.B.4.4 **Thick-Wall AS Core No. 34 Which Failed Due to Cracks That Were Initiated During Rebonding of Hub**

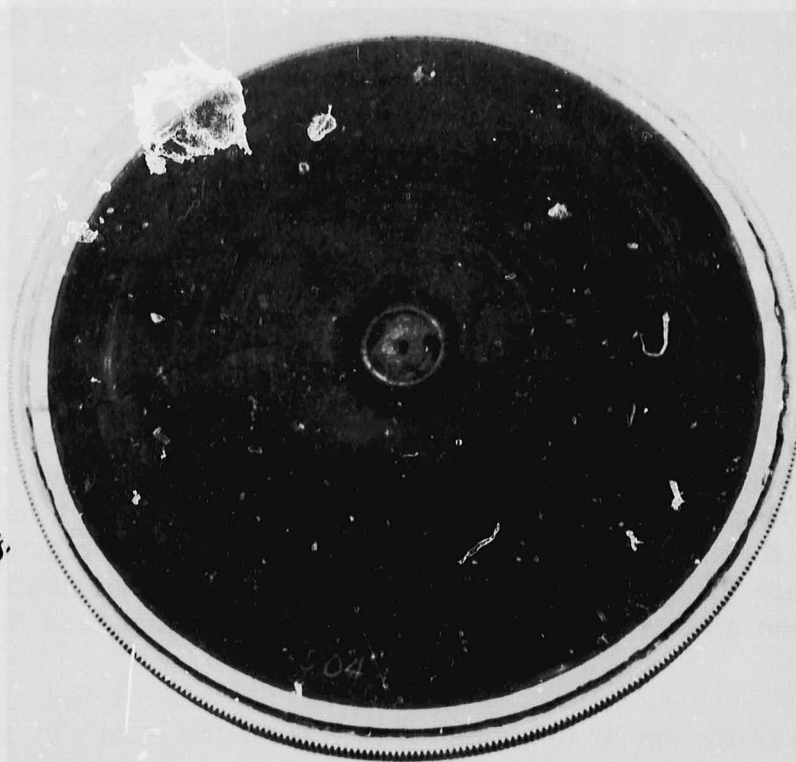
Figure I.B.4.5 **Thick-Wall AS Core No. 47 Damaged Due to Improper Engine Installation**

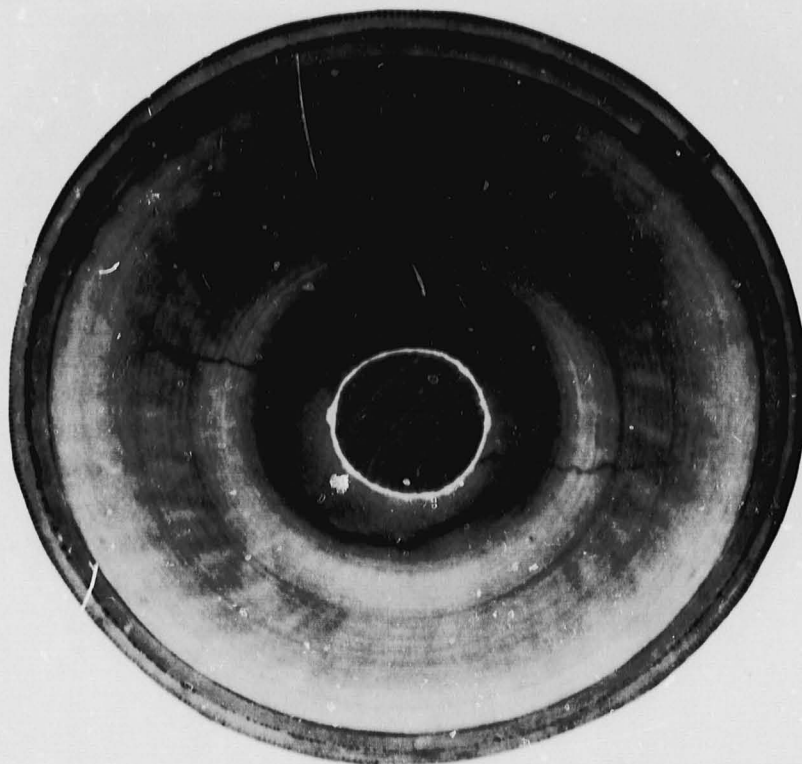
Testing of thin-wall AS Core No. 56 was terminated after 1737 hours for the same reason Core No. 34 was terminated. The hub failed in Core No. 56 after 11 hours of engine test, and when it was re-cemented back in place, radial cracks were generated in the hub region (Figure I.B.4.6.). The hub came loose again after an additional 38 hours, and it was again re-cemented, aggravating the existing cracks. Final failure occurred after 1731 hours when these cracks finally propagated to the rim.

Figure I.B.4.6 Thin-Wall AS Core No. 56 Showing Cracks Introduced When Hub Was Recemented After 11 Hours of Engine Test

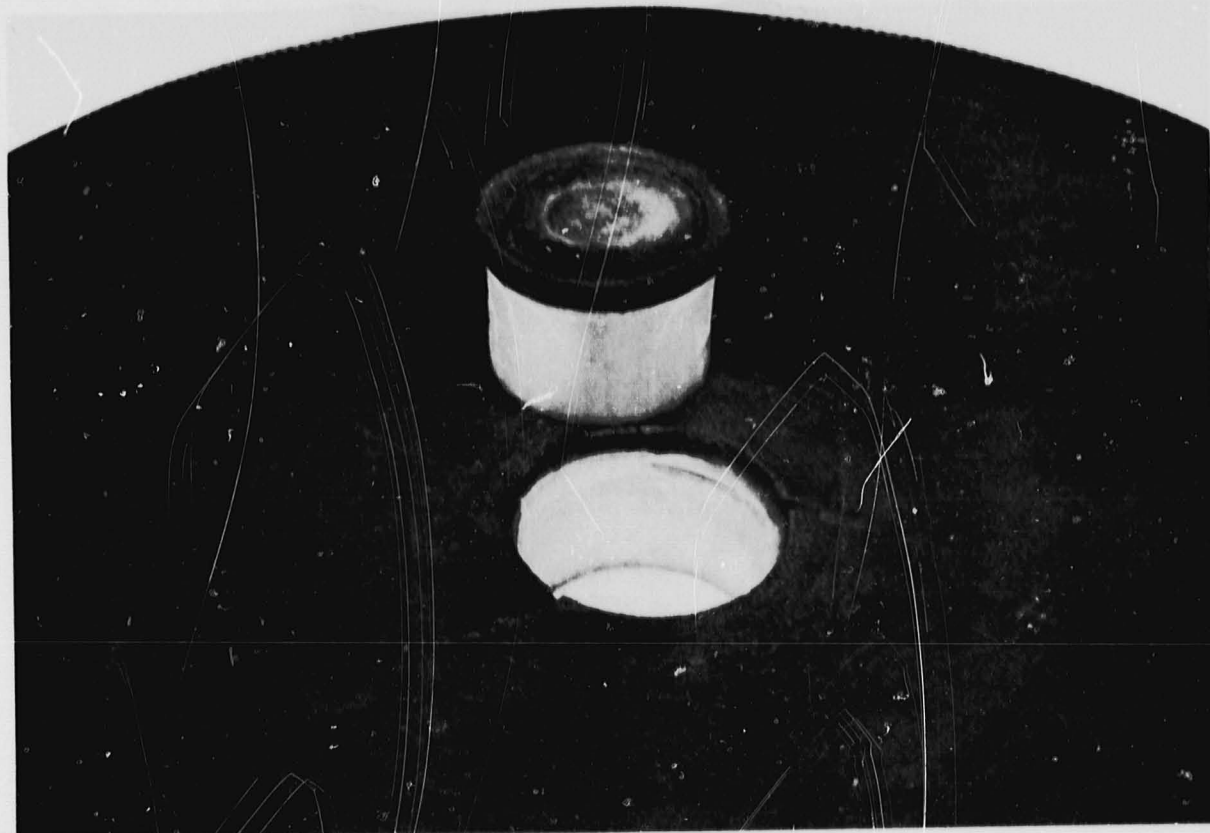
Figure I.B.4.7 Thin-Wall AS Core No. 54 Showing Failure of Cement Bonding Hub Insert in Place

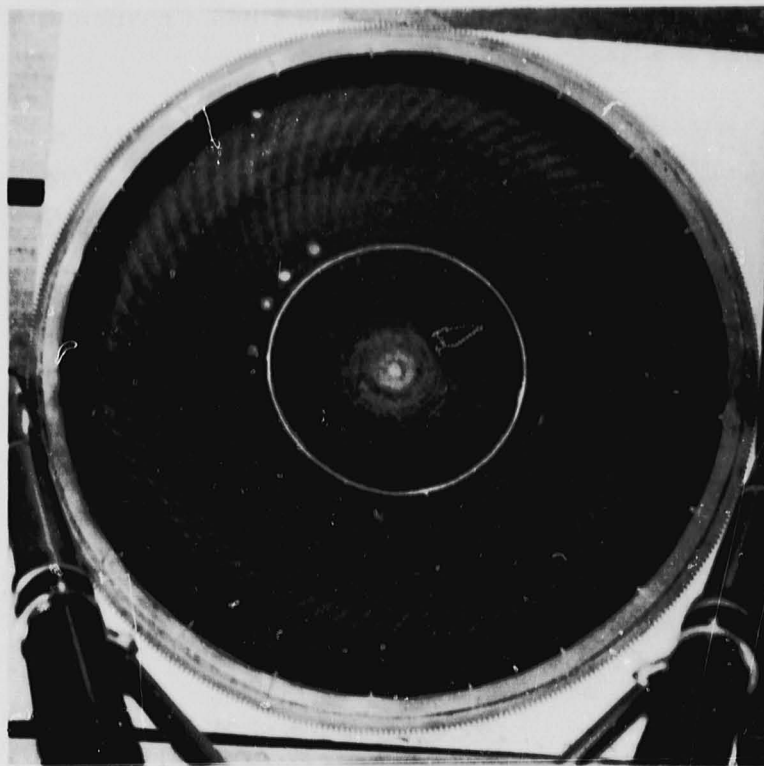
Engine tests of two early MAS regenerators are described in Section M of Reference 1. One of these early MAS cores accumulated 426 hours of engine test before it was retired. The testing of this core was terminated when the cement holding the hub or center section in place failed and caused damage in this region. Subsequently, an improved procedure for bonding the center insert to the rest of the matrix was developed. This procedure was used to cement the center insert into a MAS core fabricated by Supplier D. This core, which is shown in Figure I.B.5.1 was evaluated in both the accelerated chemical attack engine test and long term engine durability tests (Reference 2). It has now accumulated 5381 total hours of engine test.

**Figure I.B.5.1 First Generation MAS Regenerator
Fabricated by Supplier D**

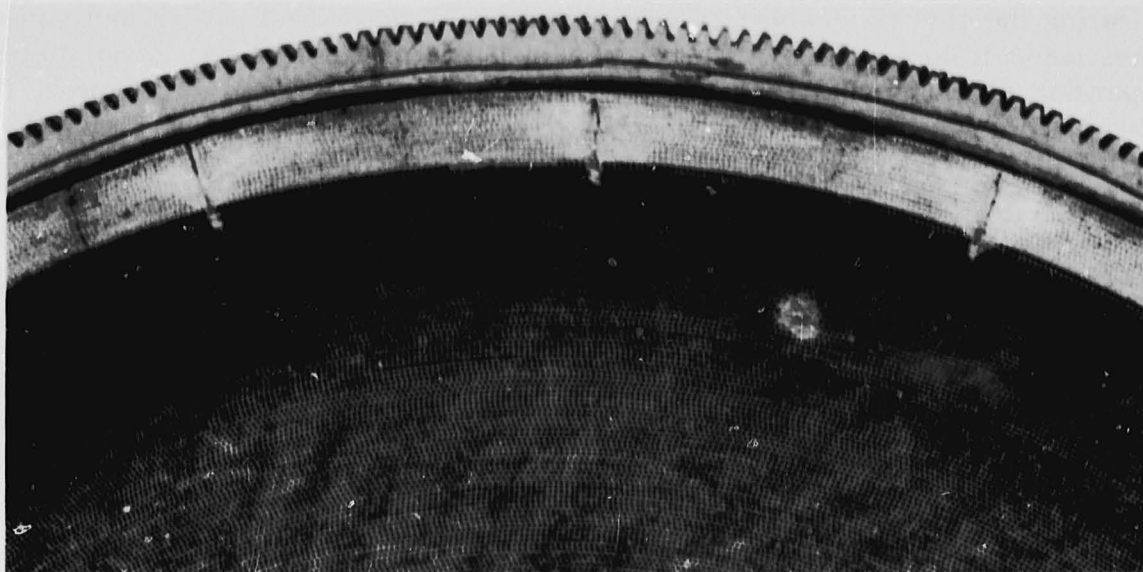
After 1552 hours on the MAS core, a safety device caused the engine to shut down automatically because of an overtemperature which was caused by clogged engine air inlet filters. On teardown inspection, it was found that several of the rim cracks in the MAS core had propagated radially inward. These cracks can be seen in the photograph taken after the emergency shutdown and presented in Figure I.B.5.3. An examination of the recorded engine data showed that the cores operated at progressively higher temperatures, in excess of 850°C (1562°F), for the last 25 hours as the filters clogged. These higher temperatures increased the thermal stress and reduced the rim safety factor an additional 15 to 25%, so that it was well below unity. Apparently the added thermal strain induced in the rim of this MAS core caused the original cracks to propagate.

Figure I.B.5.2 **MAS Regenerator Rim Showing Thermal Stress Cracks Located Between Stress Relief Slots After Operation at 800°C (1472°F)**

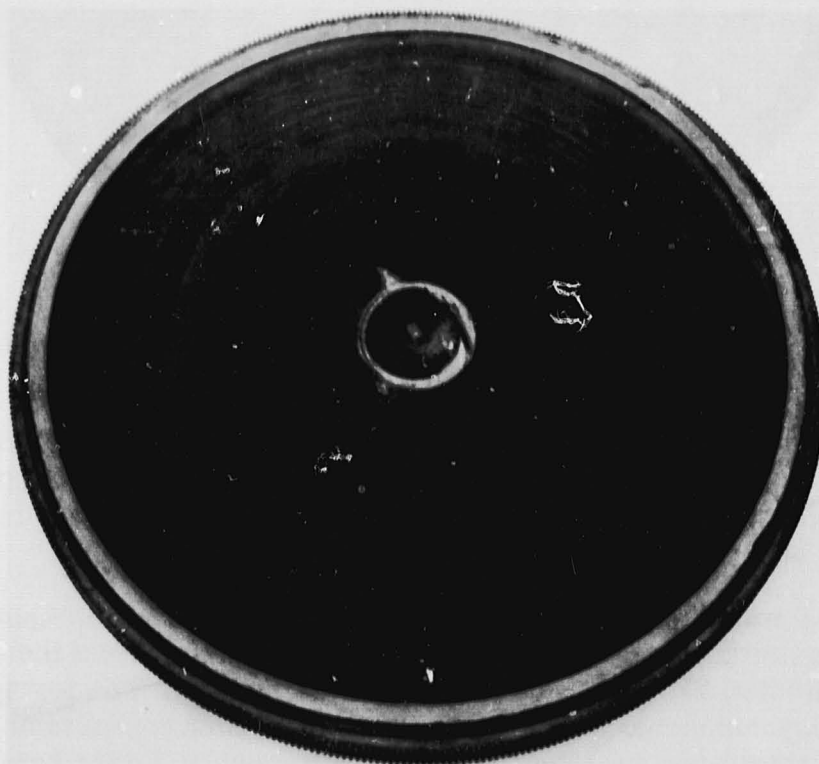
During the third quarter of 1976 under an earlier program, the cement holding the hub insert in place failed in three different thick-wall AS cores. These cores had accumulated 9 hours, 68 hours, and 2368 hours at the time of failure. Photographs of the 2368 hour failure and the hub insert are shown in Figures I.B.6.1. and I.B.6.2. In each case the failure was attributed to improper composition or improper processing of the cement itself.

Figure I.B.6.1 AS Core No. 43 After Failure of Cement Bonding Hub Insert in Place

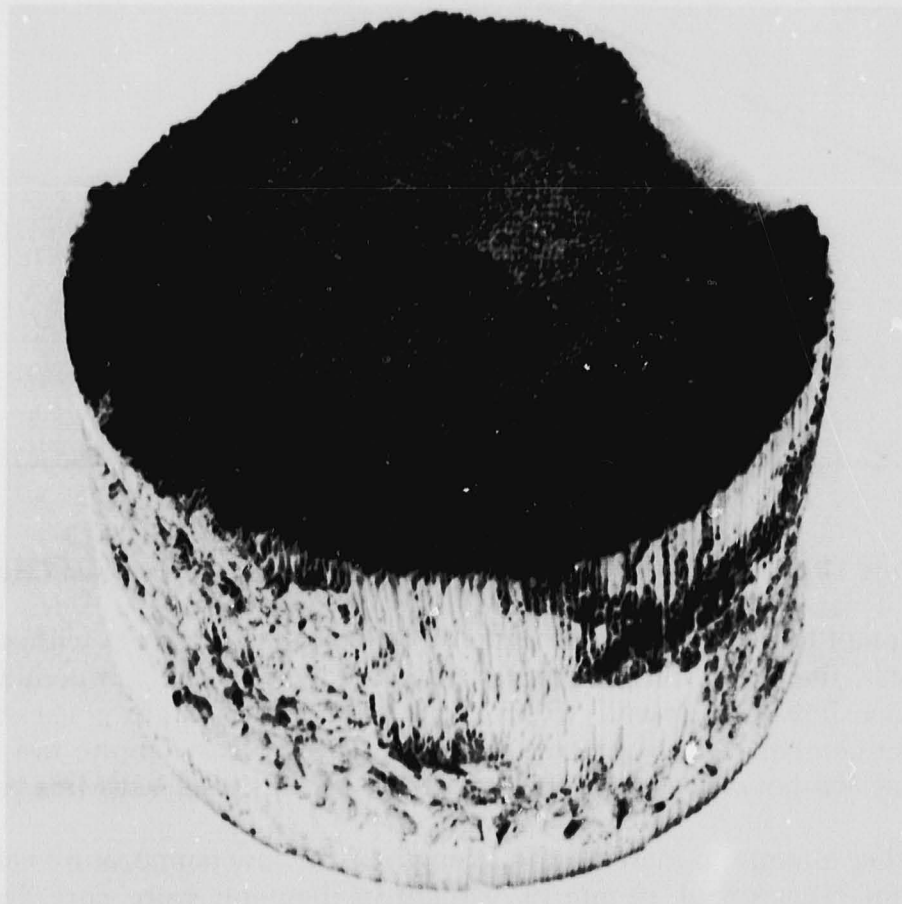
This cement, which was developed specially for use with AS material, relies on a foaming action or expansion when it is fired to properly bond the two ceramic pieces together. An examination of Figure I.B.6.2 shows that this foaming action occurred at both faces of the insert, but did not take place in the center. The cement actually shrank away from the ceramic in the center portion of the matrix. The insert was held in place, therefore, by a thin band of cement at each core face. As the engine housing distorts or creeps with operating hours, slight additional seal rubbing forces are applied to this section of the matrix. These slight additional forces may have caused this thin band of good cement to fail.

Figure I.B.6.2 Hub Insert from Core No. 43 with Non-Foamed Cement in Center

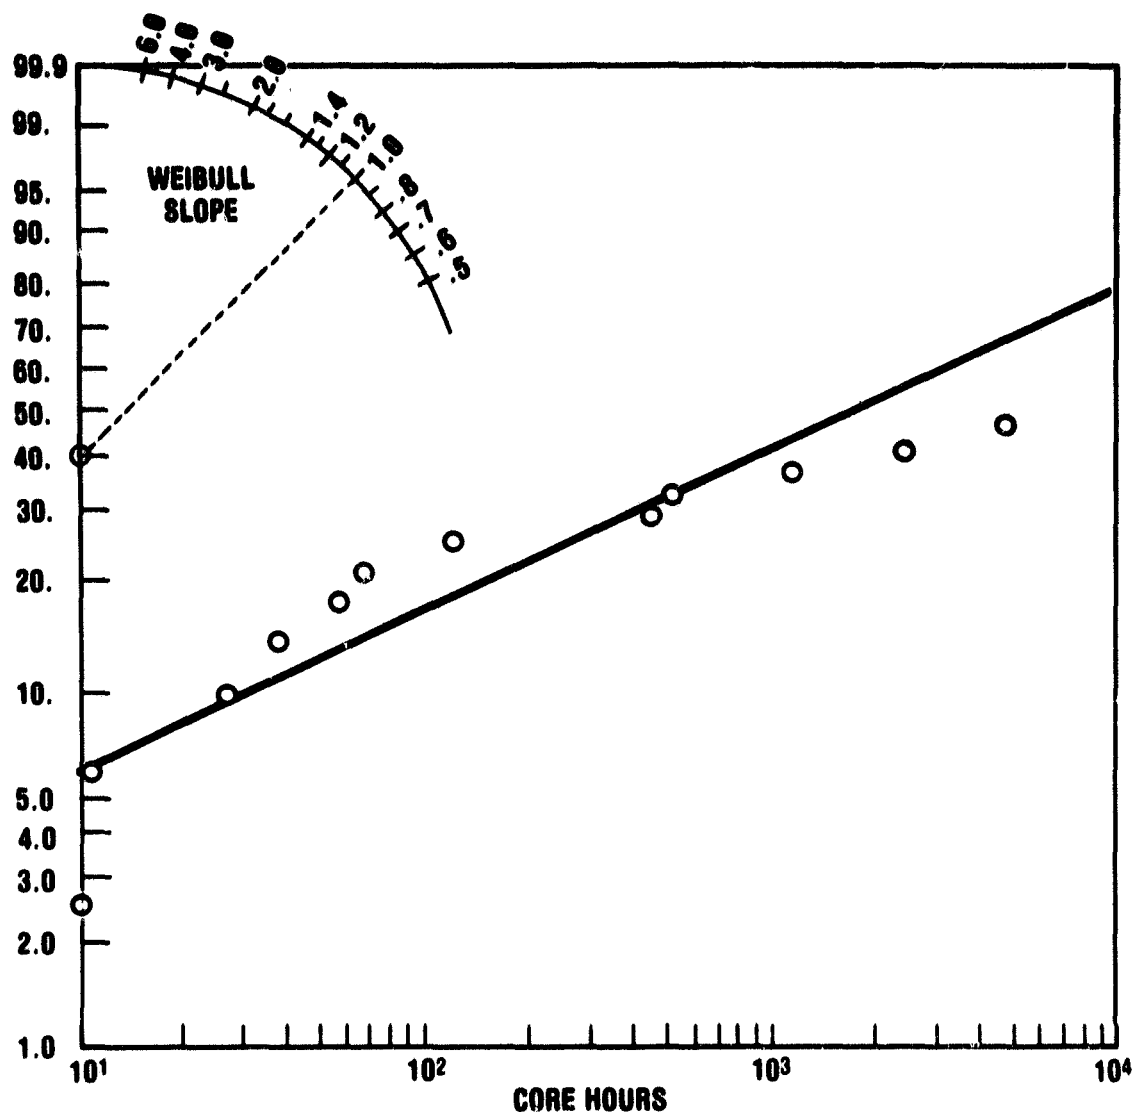
The failure of the cement that attaches the matrix hub insert is primarily a quality control problem. When properly processed the cement has good durability potential as evidenced by the Weibull distribution for these cores, Figure I.B.6.3. Based on Weibull distribution theory, 10% of these matrix inserts would be expected to separate after 30 hours of engine test. Conversely, four of the five cores that have attained 10,000 hours durability contain the original matrix insert hub.

Figure I.B.6.3 Failure History of AS Cores with Supplier A Foam Cement

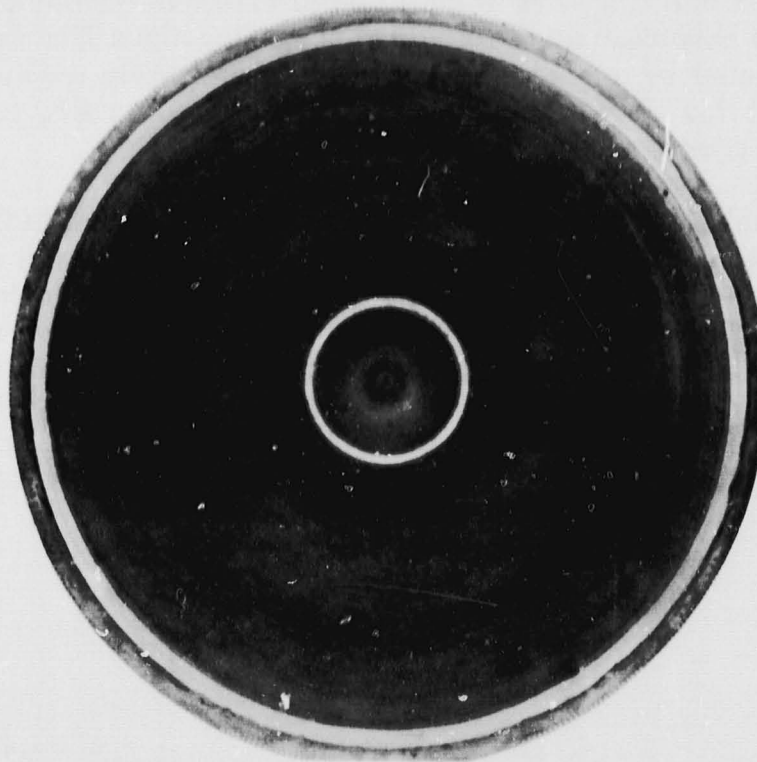
Figure I.B.6.5 Thick-Wall AS Core No. 43 with Hub Repaired with High Temperature Cement and Solid Ceramic Ring

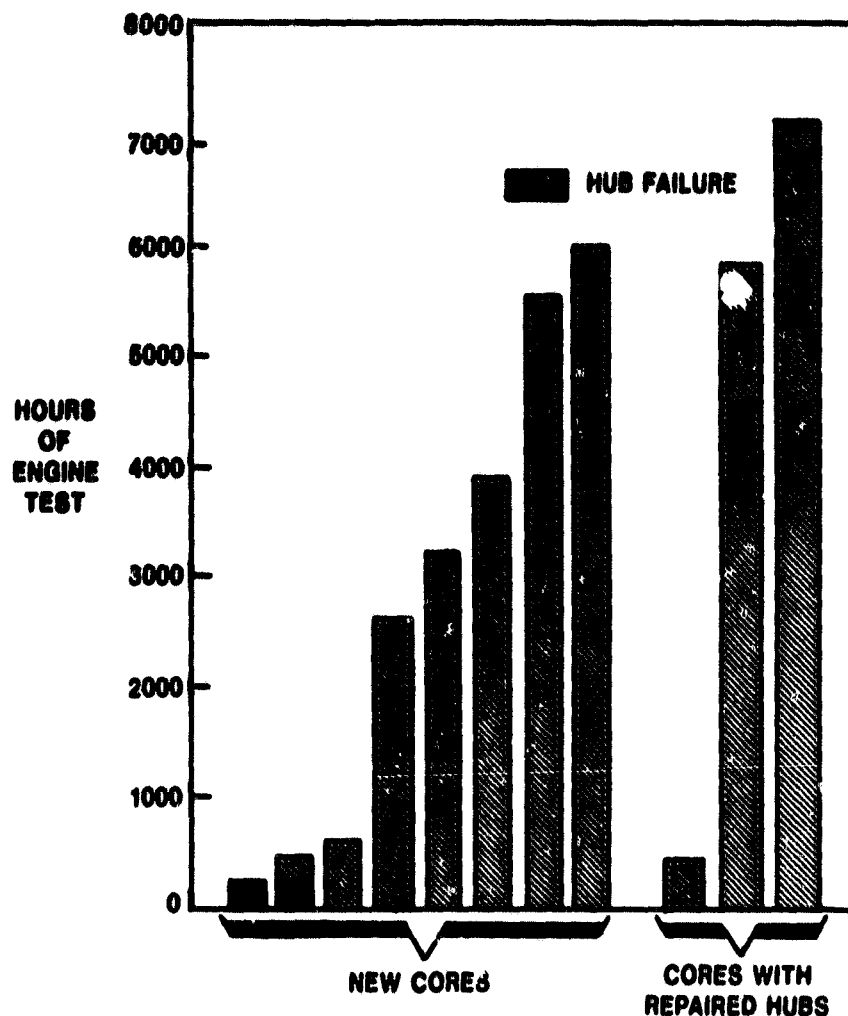
A Weibull analysis of the original hub cement configuration indicates a B₁₀ life of 30 hours. The redesigned hub, which consists of the hub insert cemented into a thin ceramic ring which is then cemented into the matrix, appears to have corrected this problem. Although one early hour failure of this configuration is still without explanation, the other ten hubs of this configuration have accumulated 35,000 hours of engine test without distress. Since at least two failures are needed before a Weibull failure analysis can be made, a projection on the B₁₀ life of the redesigned hub cannot be made. Its durability and reliability, however, appears to be adequate.

Figure I.B.6.6 Durability Record of Cores with Solid Ceramic Ring Around Hub Insert

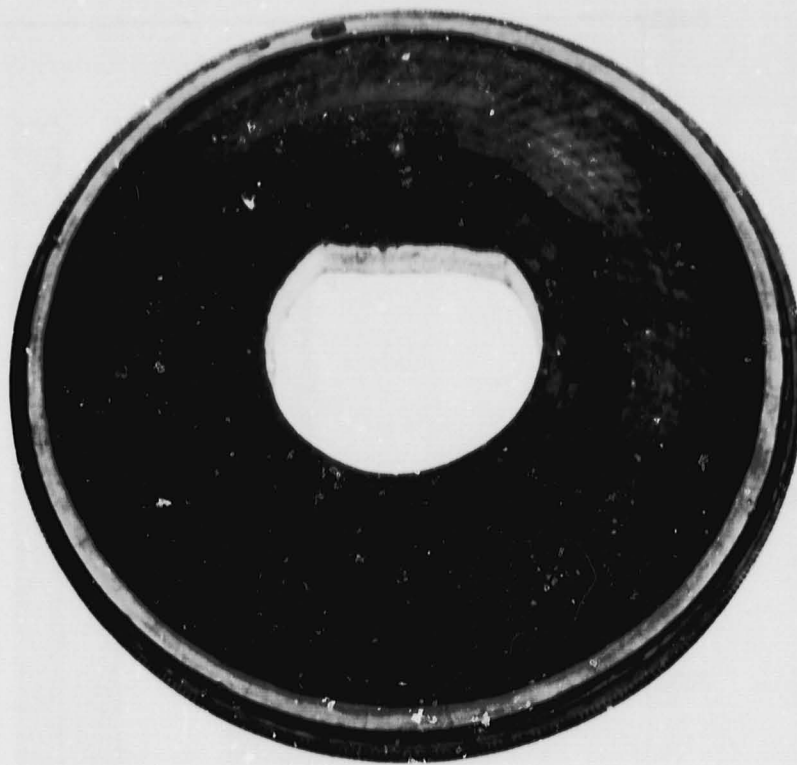
Figure I.B.7.1 shows the hub cement failure that occurred in the Supplier D's first-generation MAS core described in the previous section. The hub in this core had been cemented in place with the same low temperature cement used with the AS core shown in Figure I.B.6.4. The cement used in the MAS core lasted 3752 hours before it failed. The hub in this core was recemented with low temperature cement and has accumulated another 1628 hours. Figure I.B.7.2 shows a hub failure that occurred in Supplier D's second-generation MAS regenerator after 473 hours.

Figure I.B.7.1 **Supplier D First Generation MAS Core with
Hub Cement Failure After 3752 Hours**

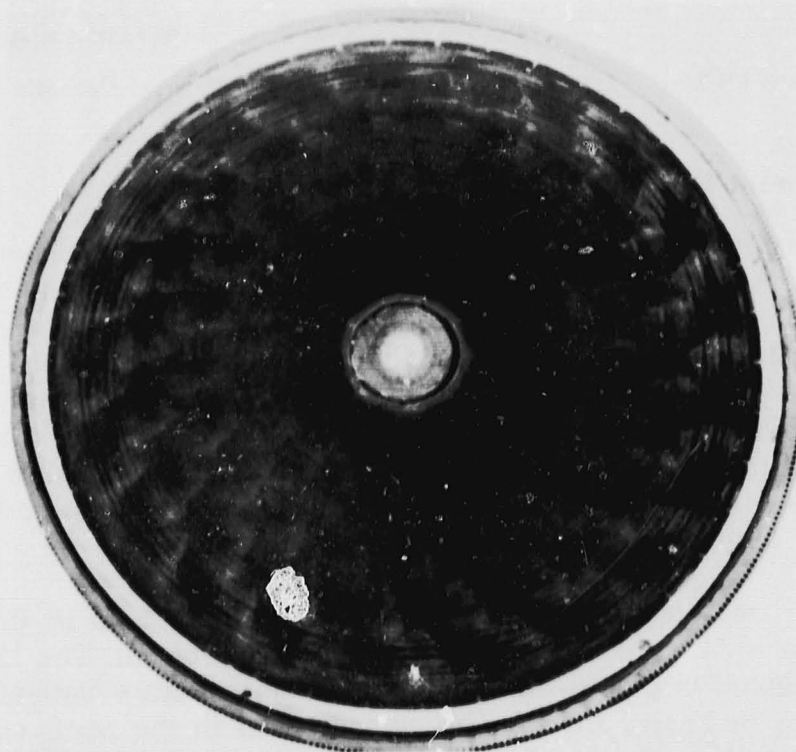
Figure I.B.7.2 **Supplier D Second Generation MAS Core
with Hub Cement Failure After 473 Hours**

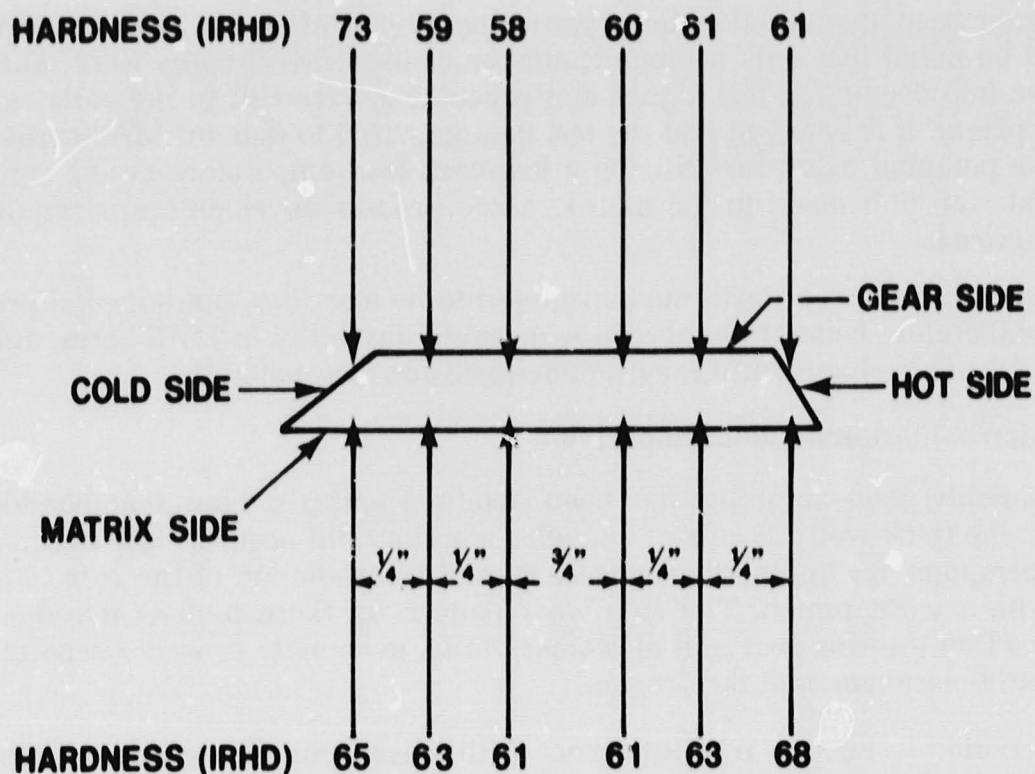
Figure I.B.8.1 Hardness Readings in Elastomer After 6935 Hours of Engine Operation

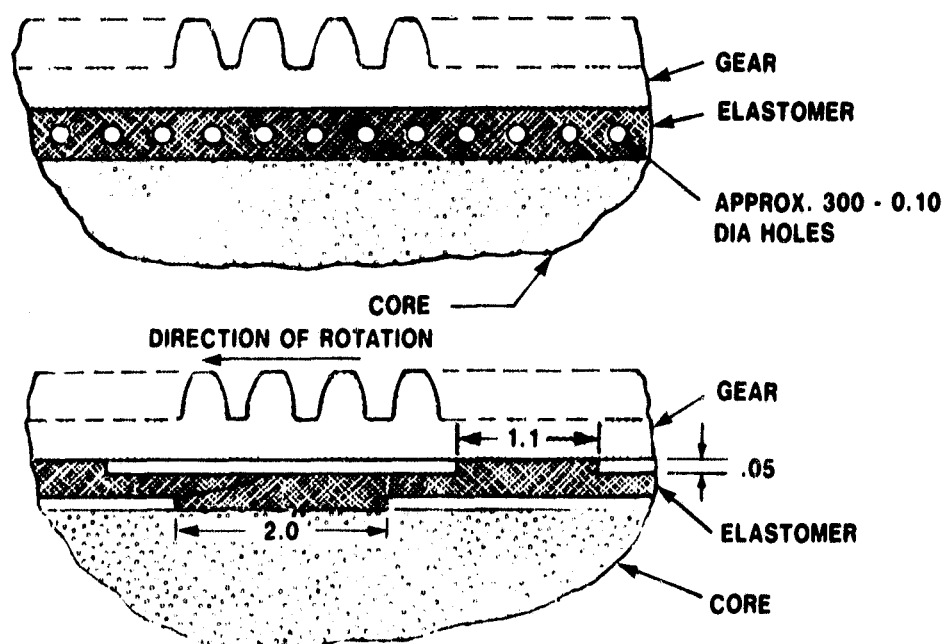
Alternate approaches for increased compliance utilizing mechanical changes, but still retaining the same elastomer, are shown in Figure I.B.8.4. The upper configuration in the illustration incorporated over 300 holes in the elastomer and results in a 50% reduction in the radial modulus of the elastomer. The lower configuration utilizes slots to reduce the radial modulus by almost 95%. Both are discussed in greater detail in Section V.B.3.

Figure I.B.8.4 Compliant Elastomer Schemes

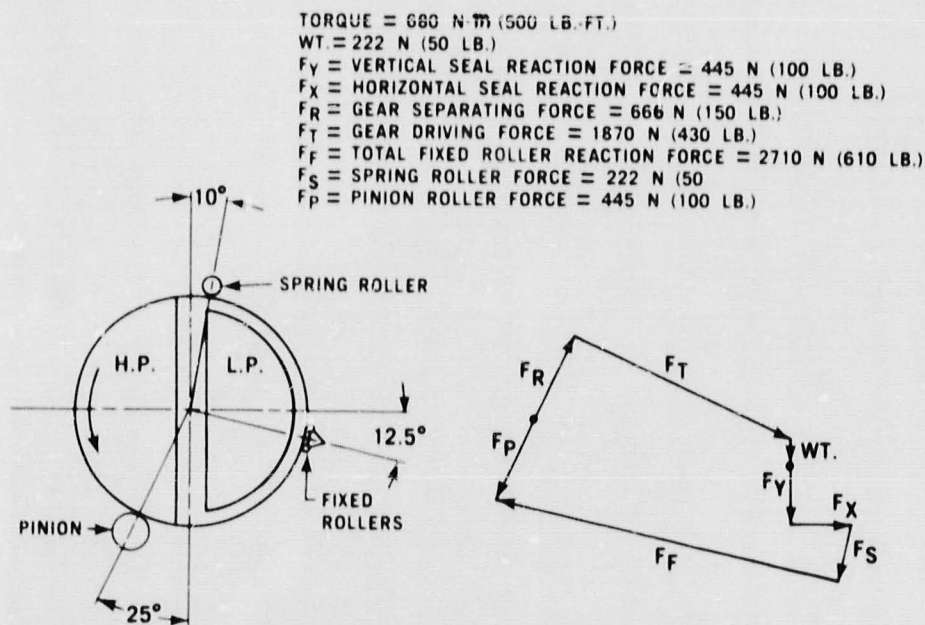
Figure I.B.9.2 illustrates the force diagram of the present design. Since the major reaction force is at the fixed roller location, a yoke with two rollers is utilized (Figure I.B.9.3) at this point. The lightly loaded spring roller and pinion locations are shown on Figures I.B.9.4 and I.B.9.5, respectively. Except for the pinion location the roller assemblies contain an outer race support ring (Figure I.B.9.6) for the bearing. This provides additional rigidity, reduced bearing speeds, and lower contact stresses in the bearing.

Figure I.B.3.2 Regenerator Force Resolution for the Modified Rim Support System at 680 Nm (500 ft-lbs) Torque Condition

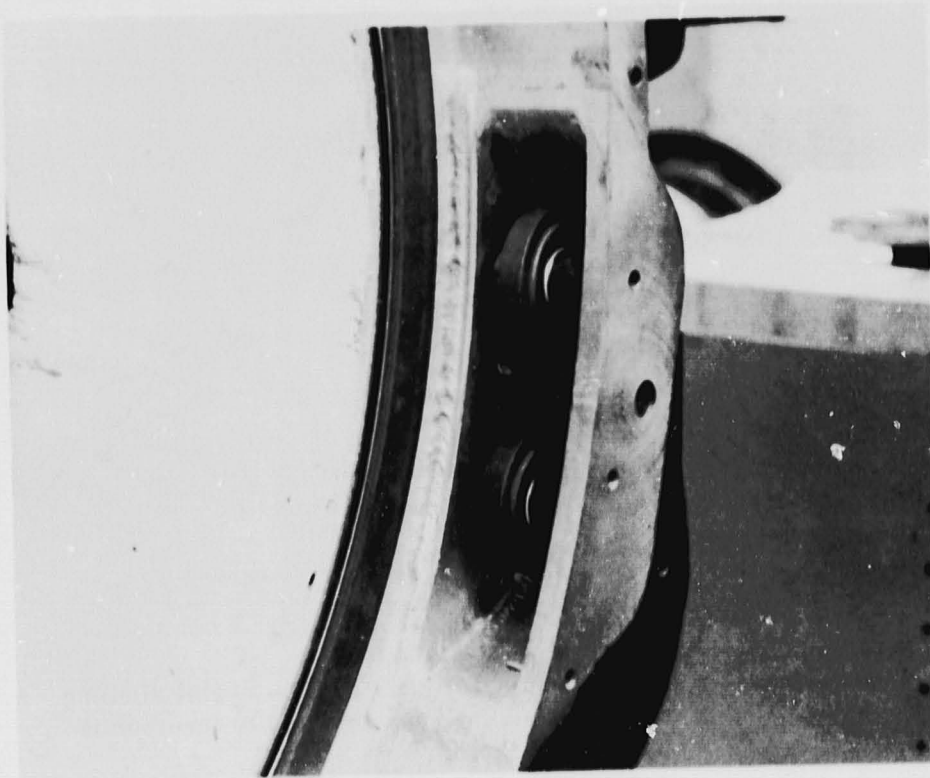
Figure I.B.9.3 **Photograph of Ford 707 Turbine Engine Housing
Showing Location of Fixed-Support Rollers**

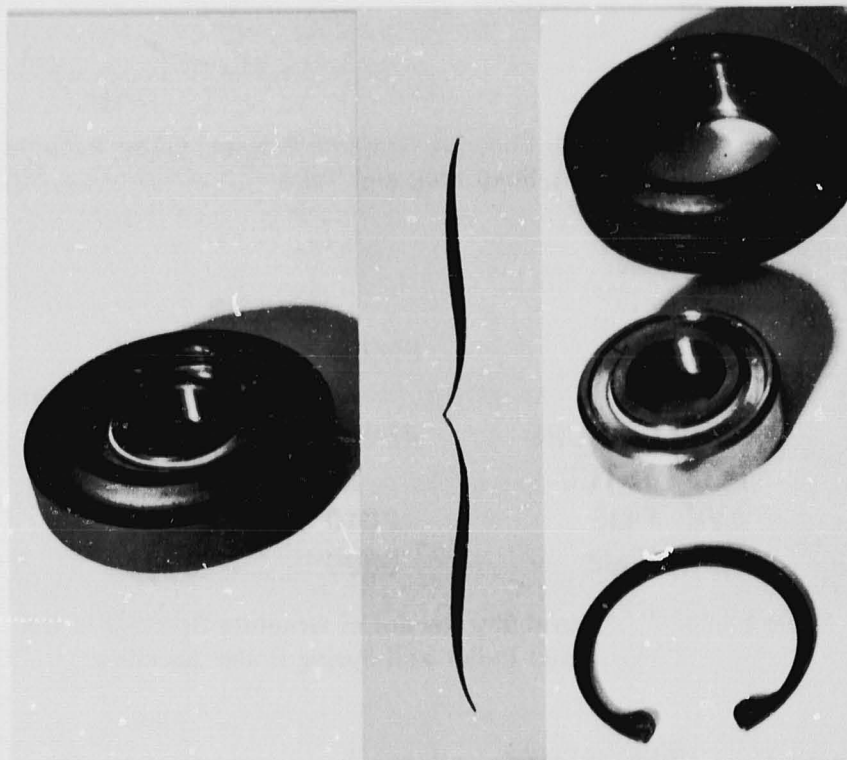
Figure I.B.9.6 **Photograph Showing Ball Bearing, Outer Race
Support Ring and Snap Ring**

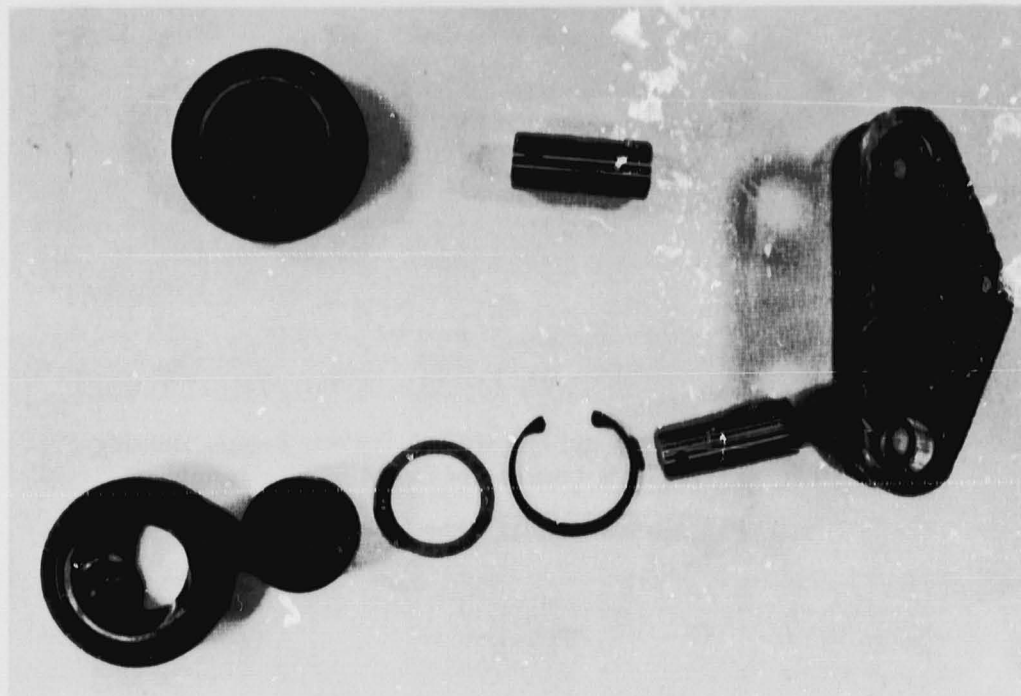
In an effort to develop a more maintenance-free system, the ball bearings were replaced with a solid graphite bearing. This graphite bearing along with its outer steel roller or tire is shown in Figure I.B.9.7. The graphite bearing is held in the steel tire with snap rings. The durability record of these graphite bearings is tabulated in Table I.B.9.1. In the spring roller location the bearing carries a 222N (50 lb) load and in the fixed roller location it carries 1355N (305 lb) load. None of these bearings have failed and the wear appears satisfactory. By mid-1978, all of the engines then on test had been converted to the graphite bearing system.

Figure I.B.9.7 Photograph Showing Graphite Bearing, Outer Race Support Ring, Shaft, Snap Ring and Yoke

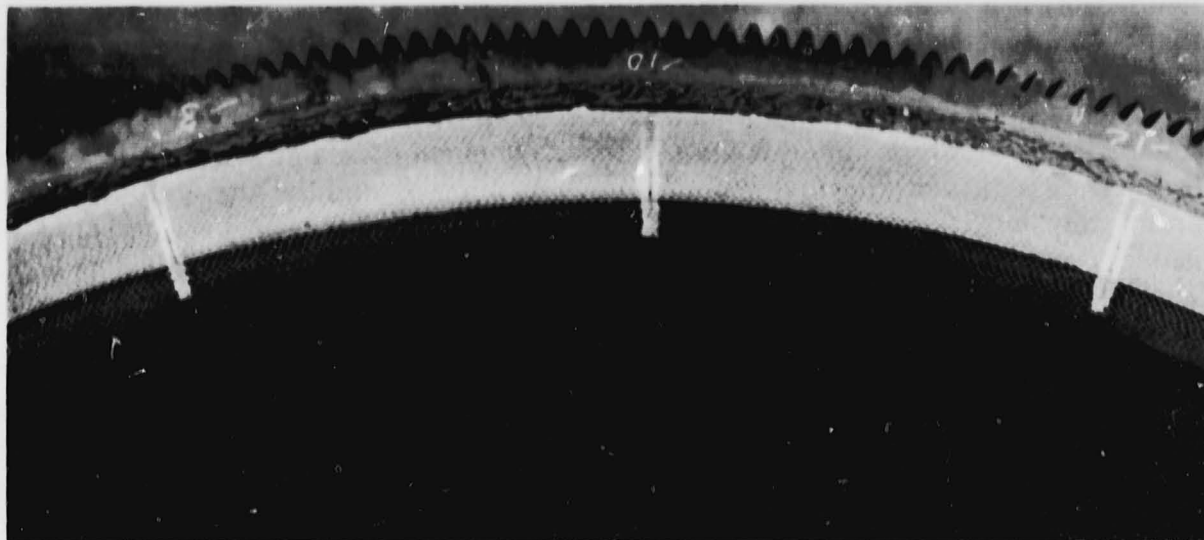
Figure II.B.1 Supplier A's CPD-6 Regenerator After 418 Hours at 982°C (1800°F)

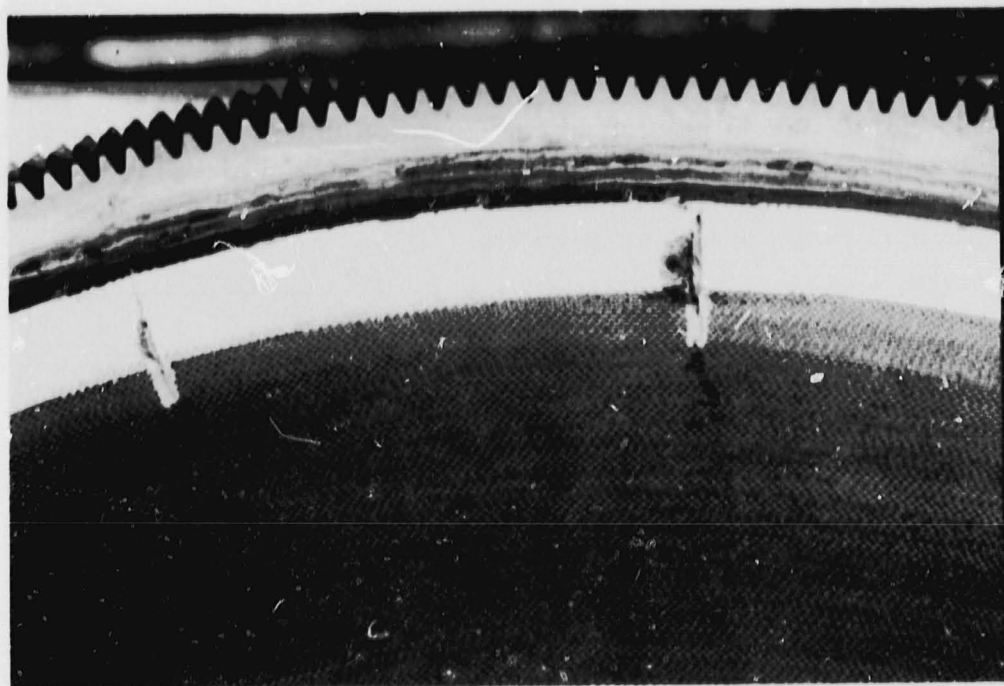
Figure II.B.2 Supplier A's CPD-6 Regenerator After 1710 Hours at 982°C (1800°F)
